### **MA 39 – VFA 2017-0308.01**

**Brandverhalten eines vorgehängten hinterlüfteten Fassadensystems mit einer Bekleidung aus Hochdrucklaminatplatten der Bezeichnung „m.look Exterior“ (Prüfung vom 8. März 2017)**

## Test Report

### Fire performance of a curtain-type, rear-ventilated facade system with panelling made of 'm.look' high-pressure laminate boards (test dated 8 March 2017)

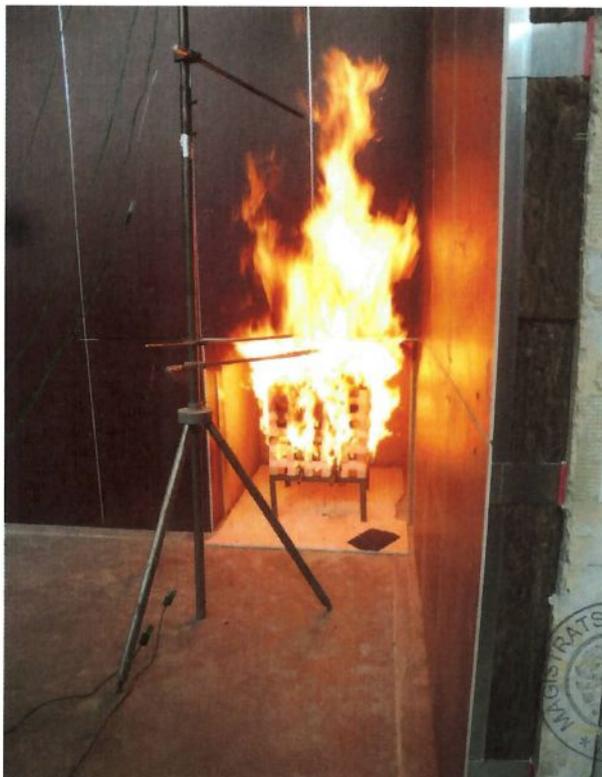
Fig. 8 (P1110022): Test specimen during the fire test — Test duration 2 minutes (connecting the fan)

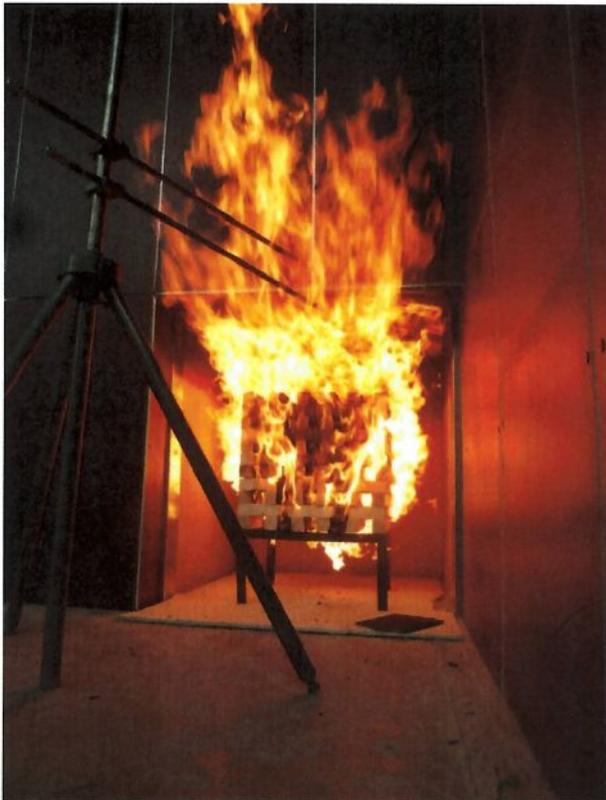
Fig. 9 (P1110023): Test specimen during the fire test — Test duration 4 minutes

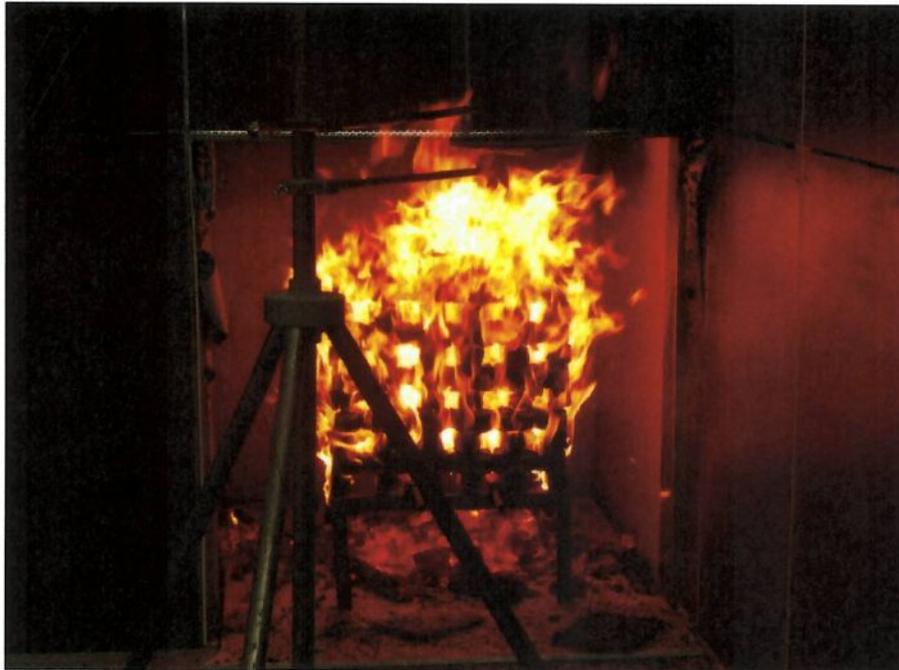
Test start:	Ignition of isopropanol
50 seconds:	Flames flare out of the fire chamber
2 minutes:	Connecting the ventilator
2 minutes:	Dark stain in the inner corner; detachment of non-burning parts of the lintel panel
4 minutes 30 seconds:	Curvature in the lintel area
14 minutes:	Flaking by the cover layer of the panel at the short end
20 minutes:	Wood crib (local fire) collapses
30 minutes:	End of test — no further changes to the system

Fig. 13 (P1110036): Test specimen during the fire test — Test duration 14 minutes (curvature of the lintel panel cladding board; flaking)

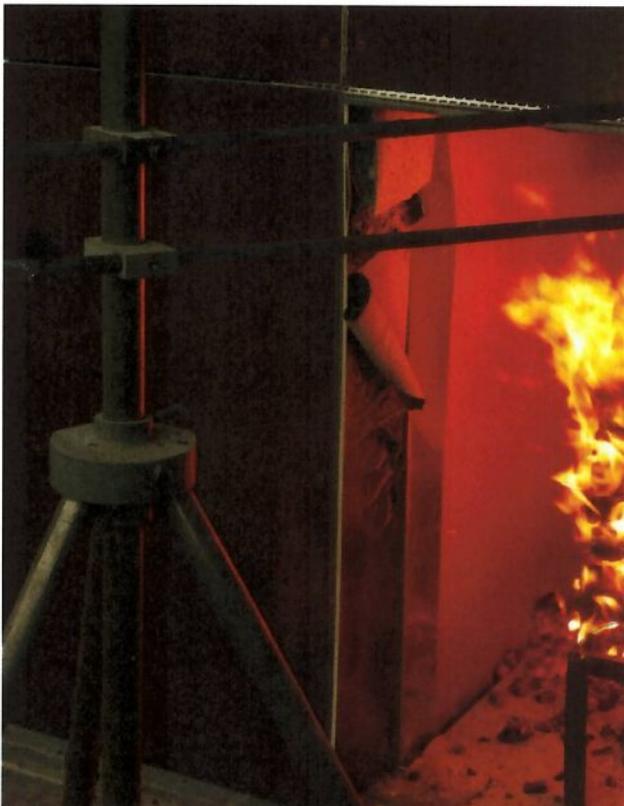
Fig. 14 (P1110038): Test specimen during the fire test — Test duration 16 minutes (flaking on the soffit panel cladding board)

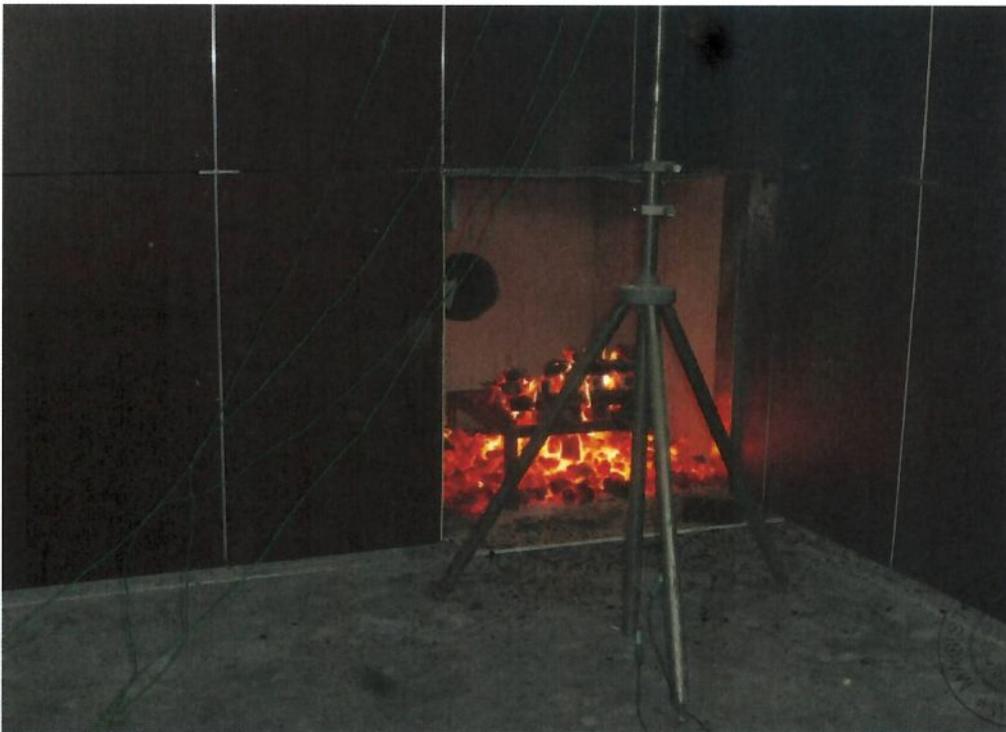
Fig. 16 (P1110042): Test specimen during the fire test — Test duration 22 minutes (collapse of the wooden brand)

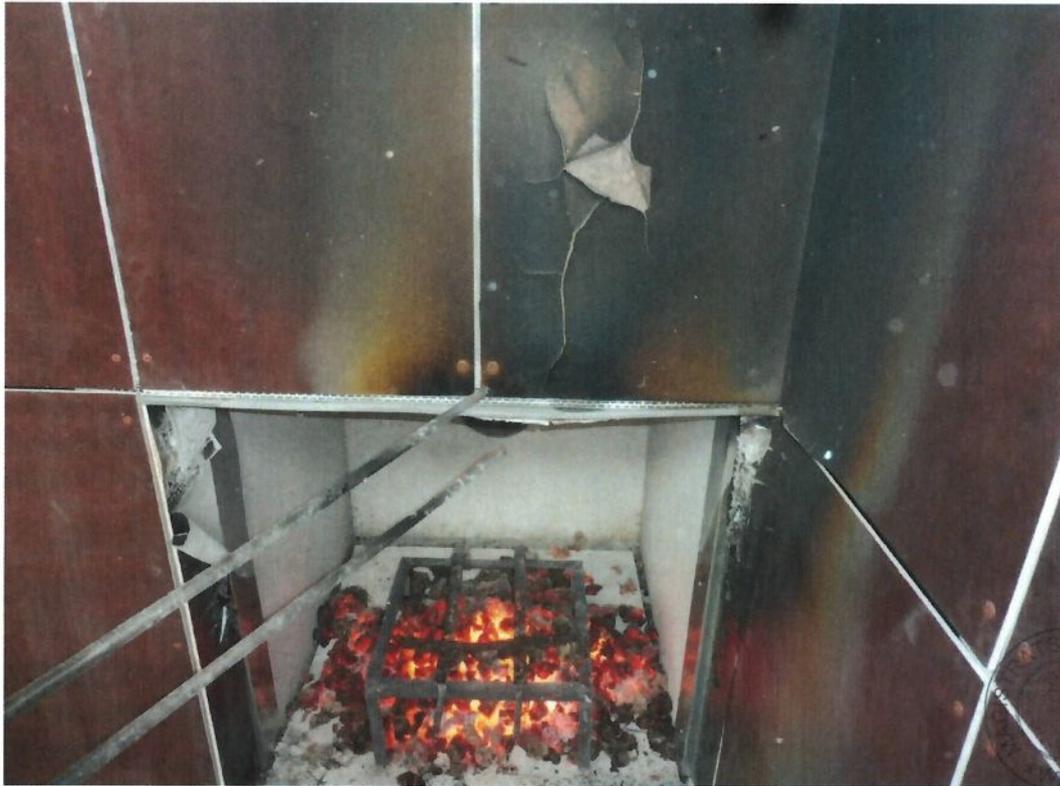
Under the test conditions selected, it was not possible to observe any optical spread of fire at or under the surface of the facade during the test. No burning parts or large parts (> 0.4 m<sup>2</sup> or > 5 kg) or any other essential parts became detached. Until such a time as the local fire collapsed, the temperatures behind the surface of the facade were never higher than those in front of the facade.

Fig. 17 (P1110044): Test specimen at the end of the fire test — Test duration 30 minutes

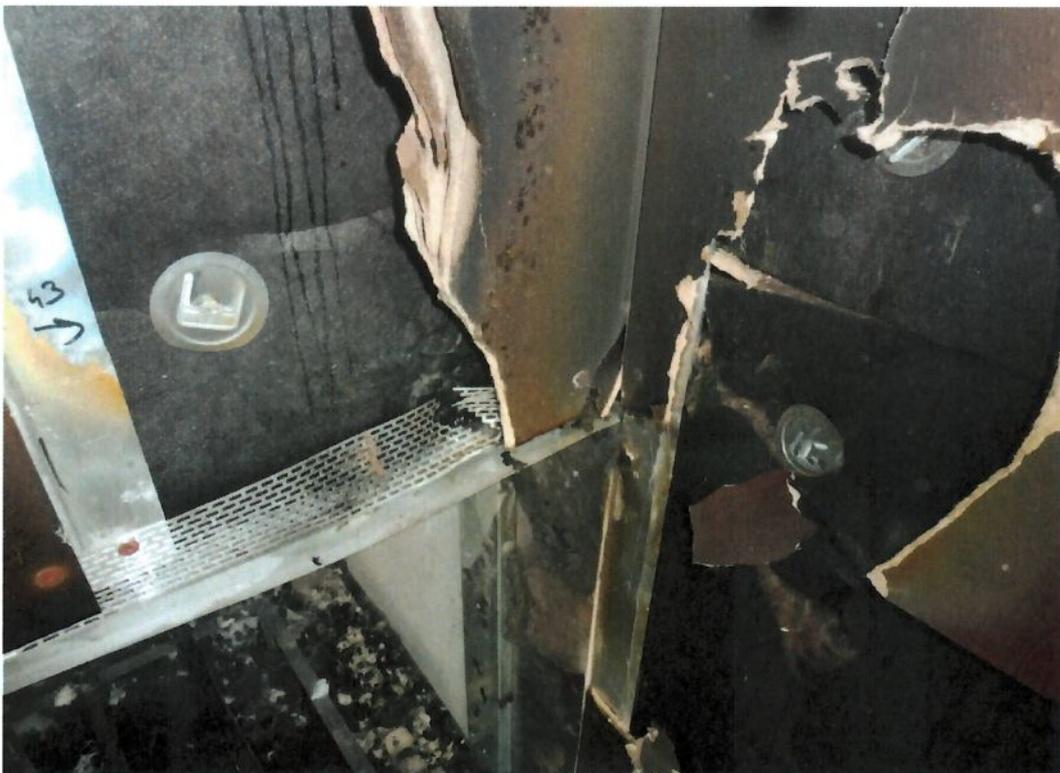
Fig. 18 (P1110046): Facade after the fire test — Detail: Damage in the inside corner

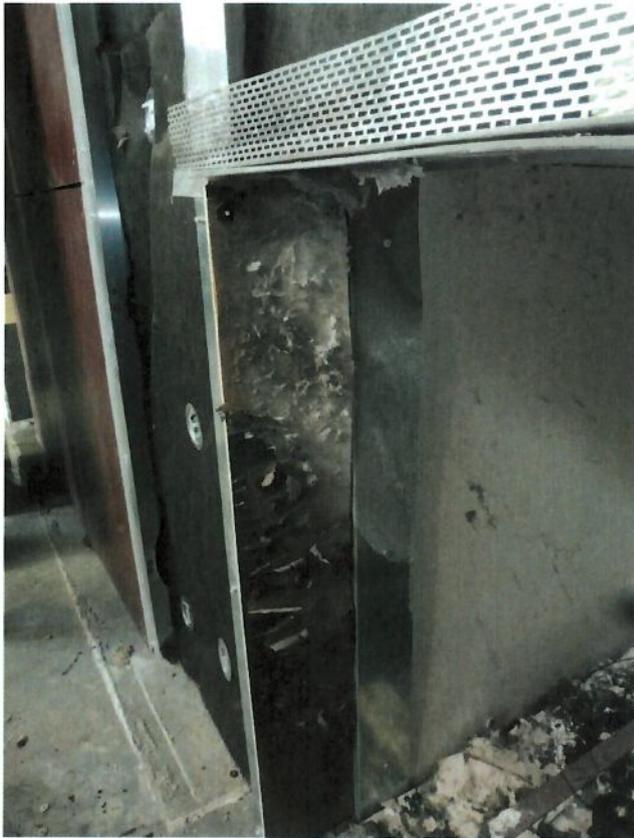
Fig. 19 (P1110049): Facade after the fire test — Detail: Damage in the lintel area

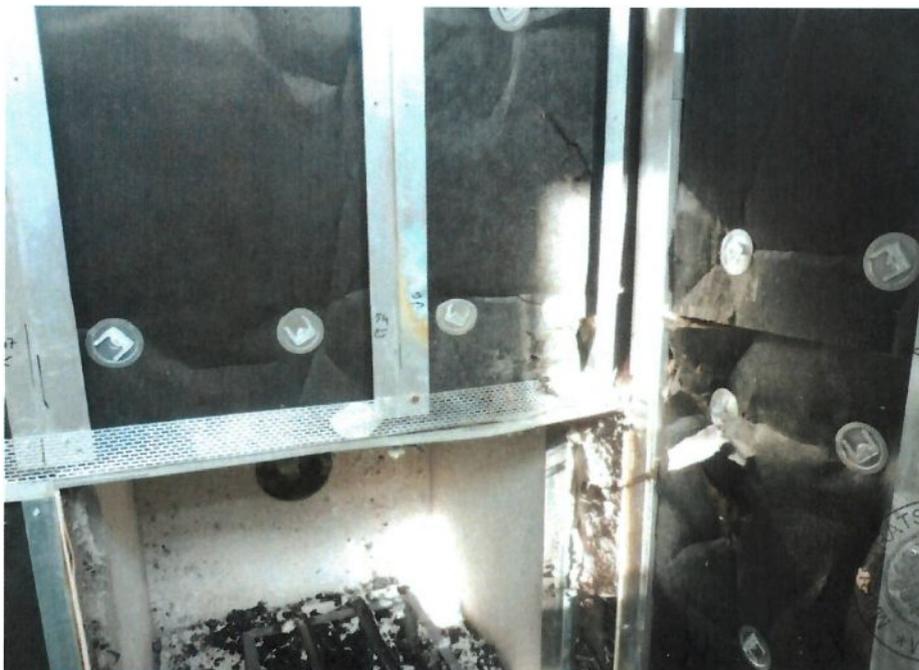
Fig. 20 (P1110052): Facade after the fire test — Damage to the substructure and insulation in the fire chamber area
